MOCK-UP PERFORMANCE TEST REPORT

Product:
UCW3500

Rendered To:
FreMarq Innovations

QCT Project No.:
QCT19-5368

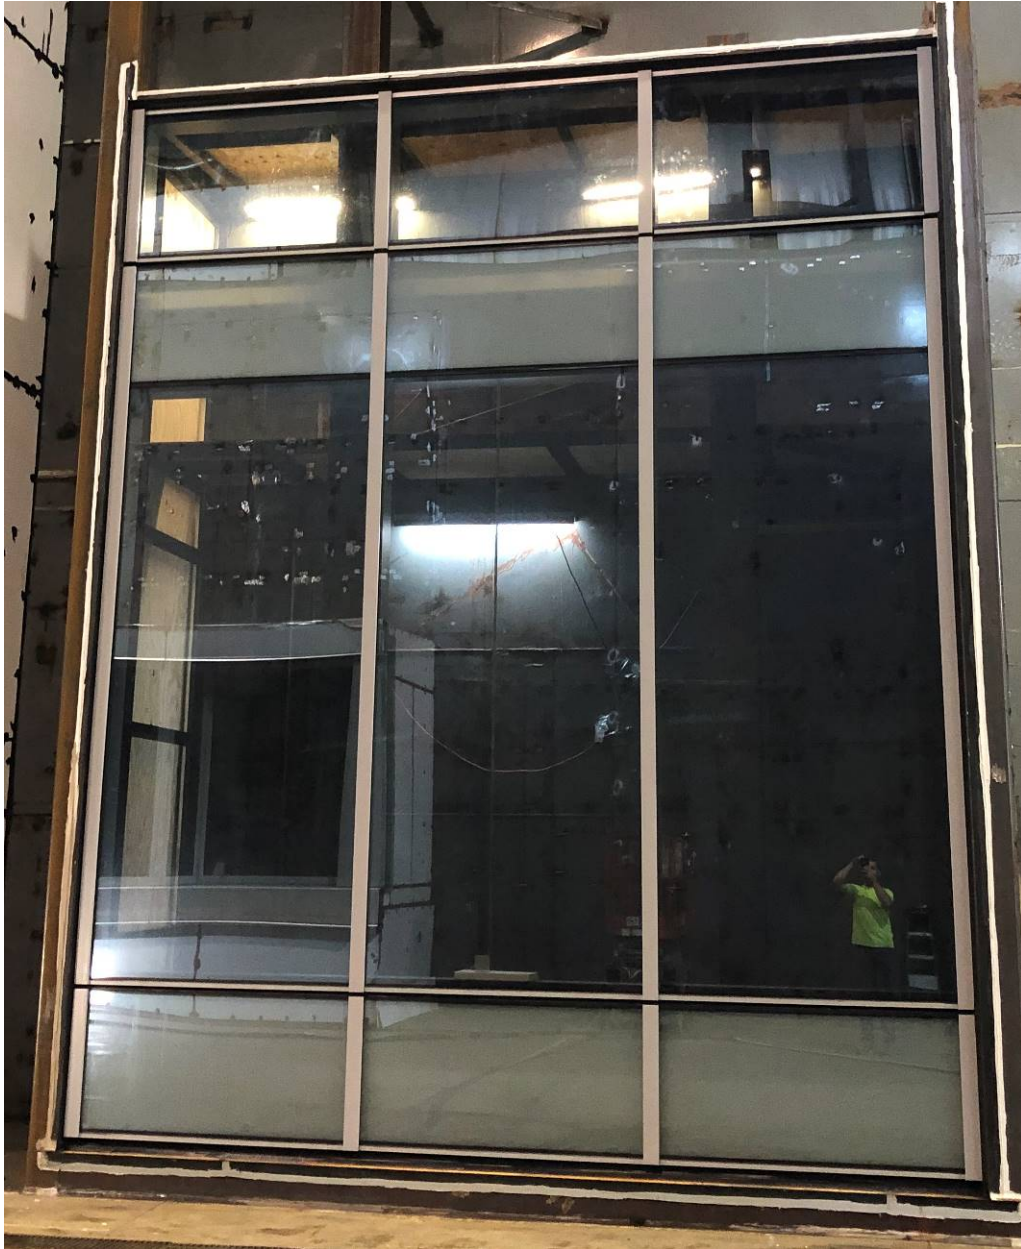
FreMarq Innovations Unitized Curtain Wall UCW3500

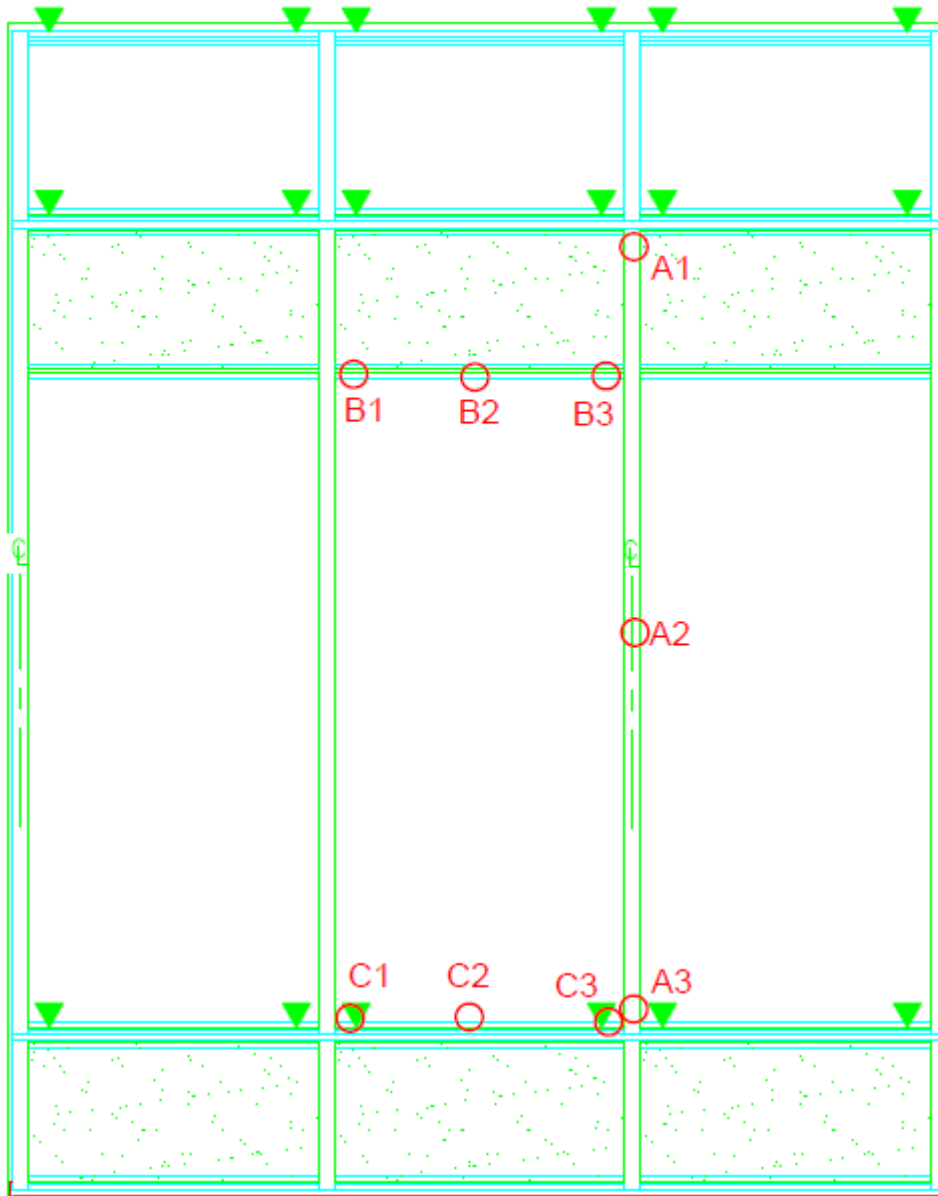
Figure 1: Deflection measurement locations during test 5.

Member	Member Span (in)	Net Deflection (in)		Allowable Deflection (in)
		+50 psf	-50 psf	
Span A (Vertical stack mullion)	146	0.41	0.35	0.75
Span B (CW horizontal)	47	0.01	0.10	0.27
Span C (Horizontal stack)	47	0.02	0.00	0.27

Permanent set measurement locations same as Deflection measurement locations noted in Test #5, Figure 1.

Member	Member Span (in)	Net Permanent Set (in)		Allowable Permanent Set (in)
		+75.0 psf	-75.0 psf	
Span A (Vertical stack mullion)	146	0.01	0.01	0.29
Span B (CW horizontal)	47	0.00	0.00	0.09
Span C (Horizontal stack)	47	0.01	0.01	0.09

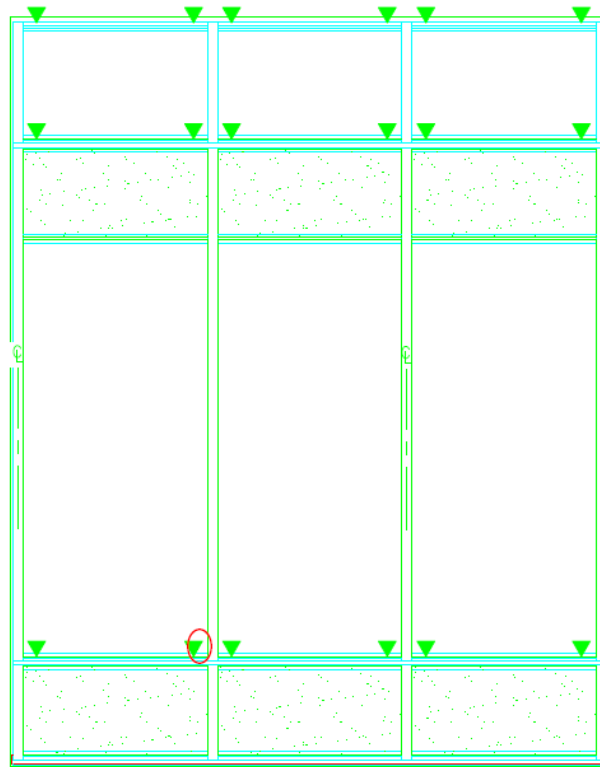
Figure 2: Location of water observed during test 10

Results: PASS, water was observed near the glazing gasket at the location indicated in figure 2. The water did not penetrate beyond the innermost plane of the CW frame.

Results: PASS, water was observed in the same location as in test 10.

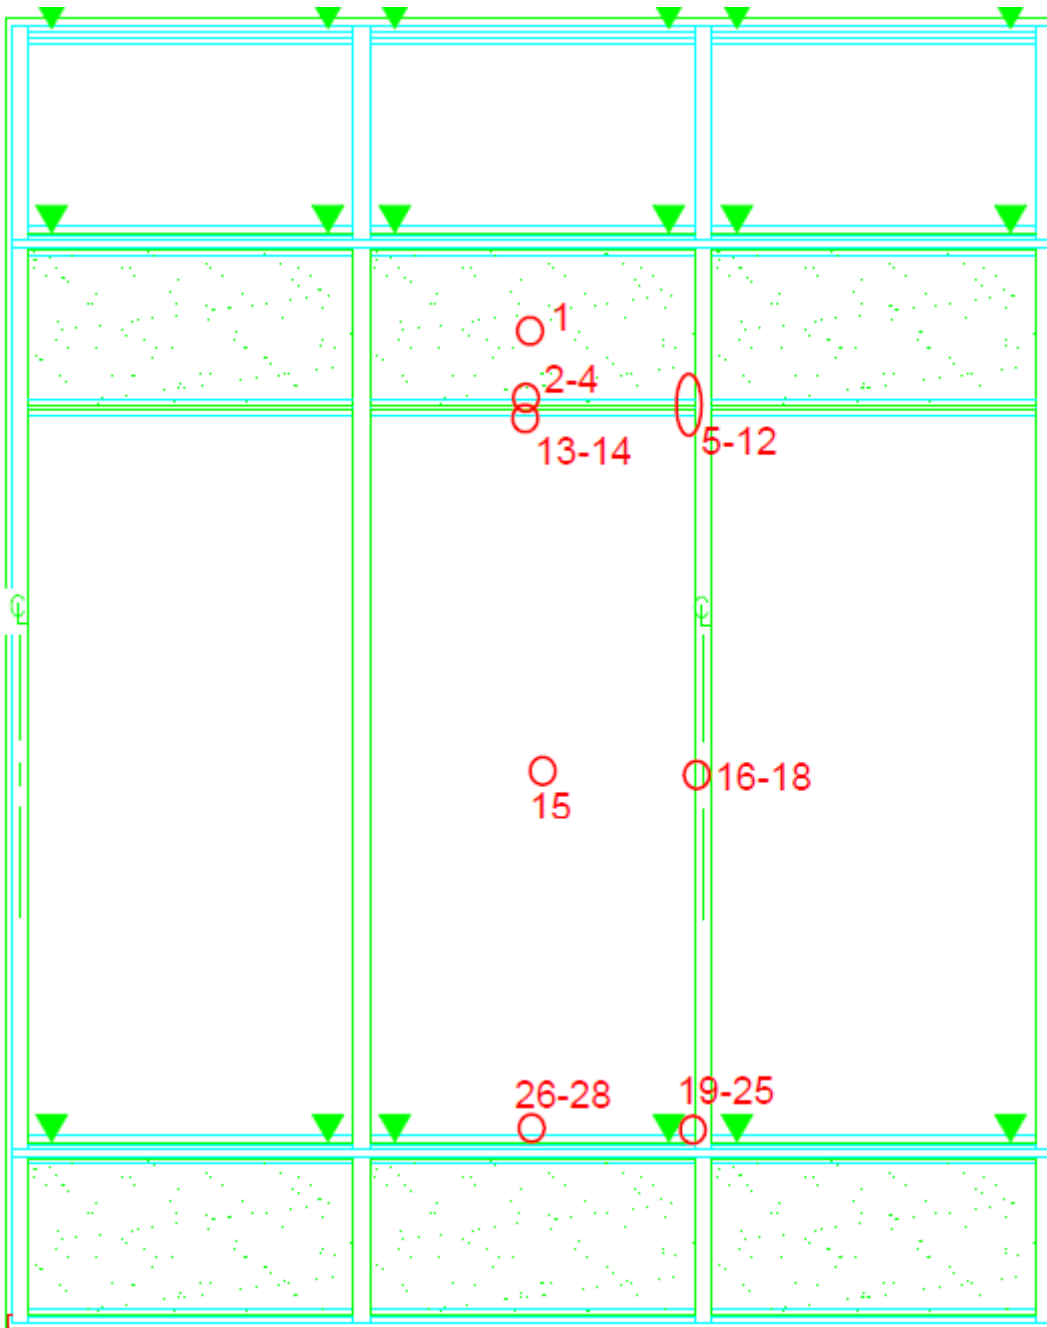
Figure 3: Interior Temperature Measurement Locations

During the Thermal Cycling test, the interior side of the mock-up was instrumented with thermocouples to measure interior surface temperatures. Upon thermal stabilization of the 0°F cold cycle, interior surface temperatures were measured and compared to the design dew point temperature. 72°F interior ambient air temperature at 30% RH yields a dew point temperature of 38.9°F.

Thermocouple No.	Description	Temperature °F
	Interior Air	69.7
	Exterior Air	-0.9
1	Center of Spandrel Glass	56.8
2	Edge of Spandrel Glass	46.6
3	Horizontal	58.1
4	Horizontal	59.8
5	Corner of Spandrel Glass	44.5
6	Vertical Mullion	59.0
7	Horizontal	58.4
8	Horizontal	59.7
9	Vertical Mullion	59.9
10	Vertical Mullion	59.1
11	Horizontal	59.3
12	Corner of Vision Glass	50.8
13	Edge of Vision Glass	56.2
14	Horizontal	60.1
15	Center of Vision Glass	59.3
16	Vertical Mullion	61.6
17	Edge of Vision Glass	53.5
18	Vertical Mullion	62.4
19	Corner of Vision Glass	42.9
20	Vertical Mullion	56.2
21	Horizontal	65.3
22	Vertical Mullion	57.7
23	Horizontal	58.4
24	Horizontal	58.4
25	Chicken Head	57.2
26	Horizontal	55.4
27	Edge of Vision Glass	44.9
28	Horizontal	58.6

**Note: Measured interior relative humidity at the time of recorded temperature data was 30%. No visible condensation was observed at the time of temperature recording.*
